## MAN-B&W 6S70 ME-C diesel engines concept, specifics of maintenance and repair in service.

**Maintenance and operational experience gained on ME-C series for 7 years handling the Q-Flex LNG Fleet:**

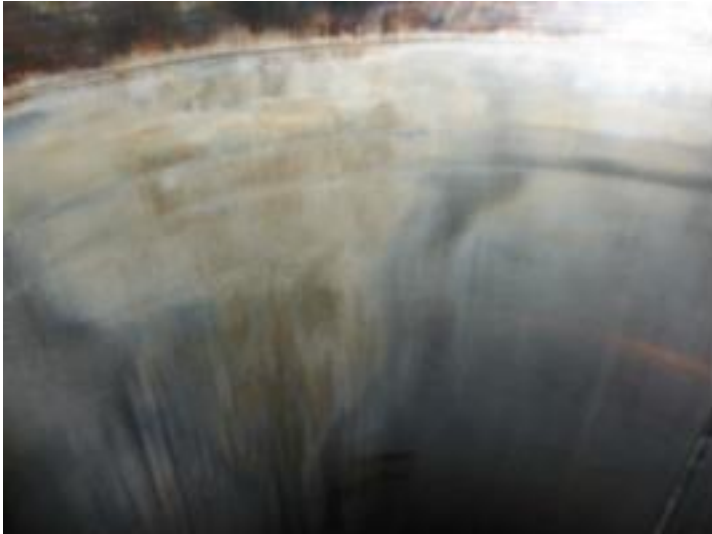
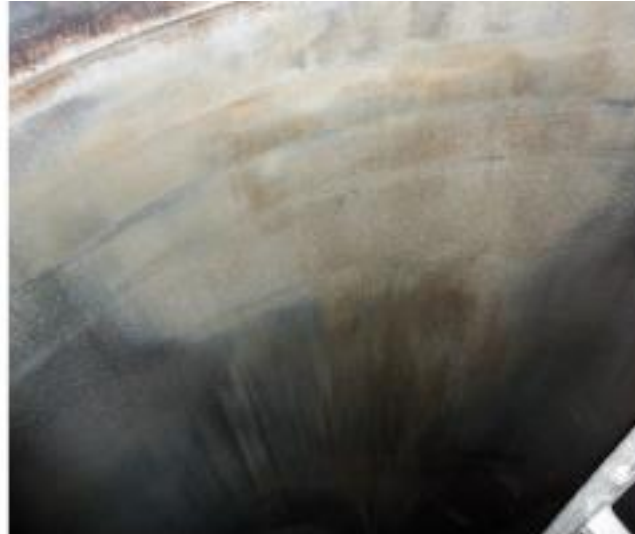
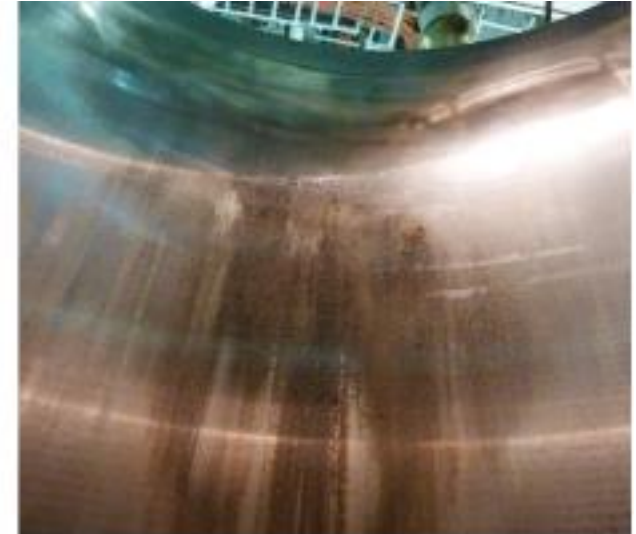
**The insulated pipes should be positioned with 5 pipes in the exhaust side and 5 pipes in the maneuvering side. New produced liners will be modified with a reduced number of cooling bores, going from 24 to 20 bores. When increasing the temperature level to 90°C we have in a few cases experienced problems with hardening of the O-rings and subsequent water leakages from the sealing of the outside water connections between the cylinder liner and cylinder cover.**

**An investigation of such incidents has proved that this has been the result of use of O-rings of wrong material (nitrile rubber).**

**The internal liner cooling is to be lowered:**

**The new spare liners onboard should be modified by replacing 10 of the existing 24 cooling pipes with insulated cooling pipes.**

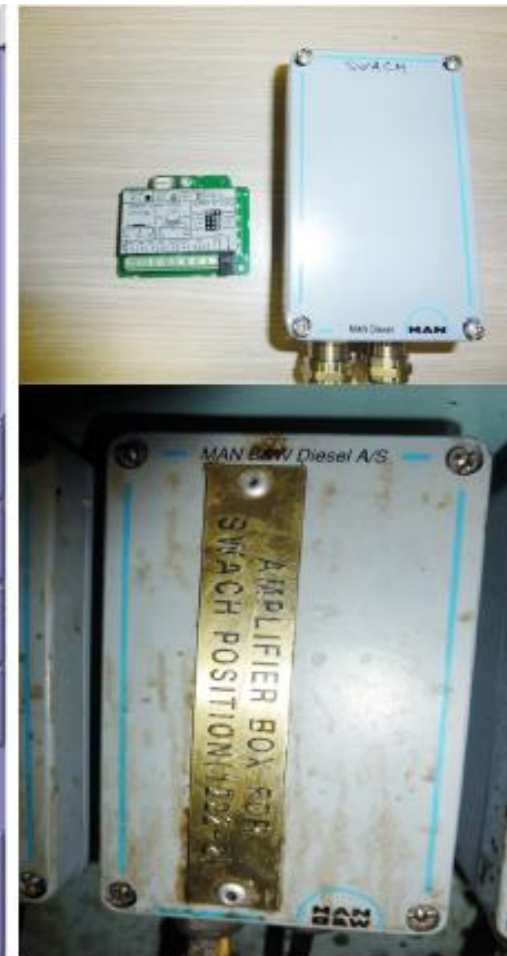
## Main hydraulic pump swash plate amplifier failure

Description: Large swashplate setpoint deviation from follow-mode pump model curve  
 Cause: Can be caused by a hydraulic leak, or mechanical pump fault such as a broken pump shaft  
 Effect: In case of a hydraulic leak, all pumps will deliver as much as needed to keep up the pressure. Hence, if the pumps cannot compensate for the leak, all pumps will swivel their swashplates towards full flow running AH or AS. In case of a mechanical fault, the non-faulty pumps will try to keep up the pressure by swiveling their swashplates to values higher than normally needed. If

Corrective measures: identification on MOP screen, evaluation and ascertainment of root cause of failure. Swash plate amplifier renewed:

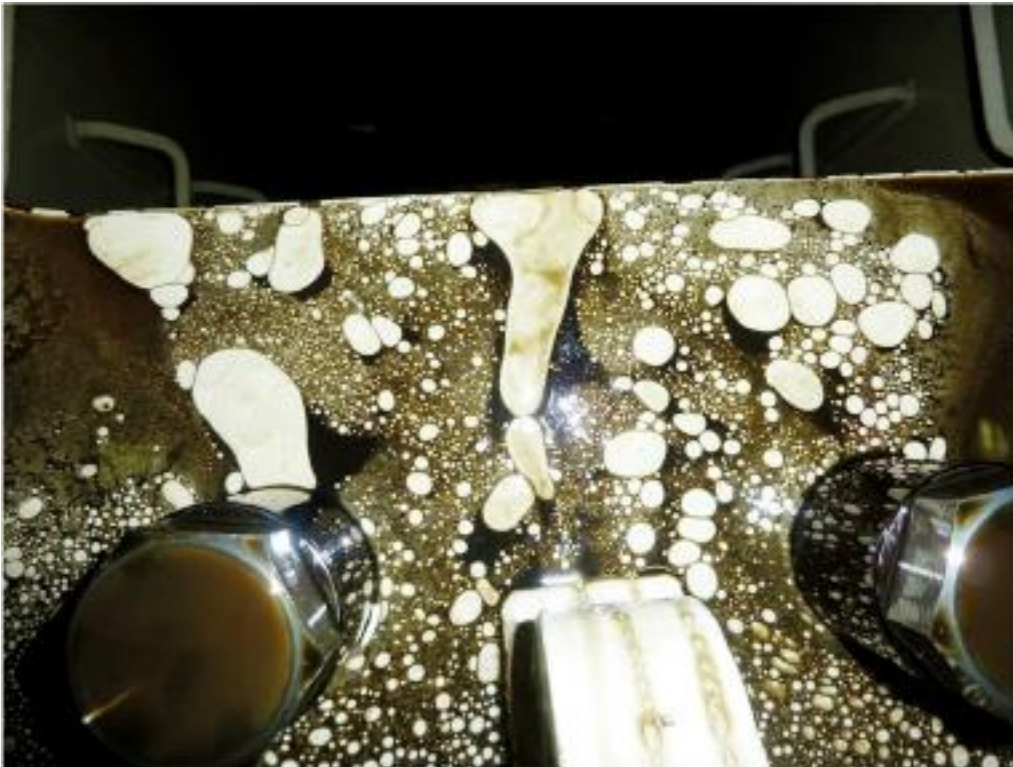
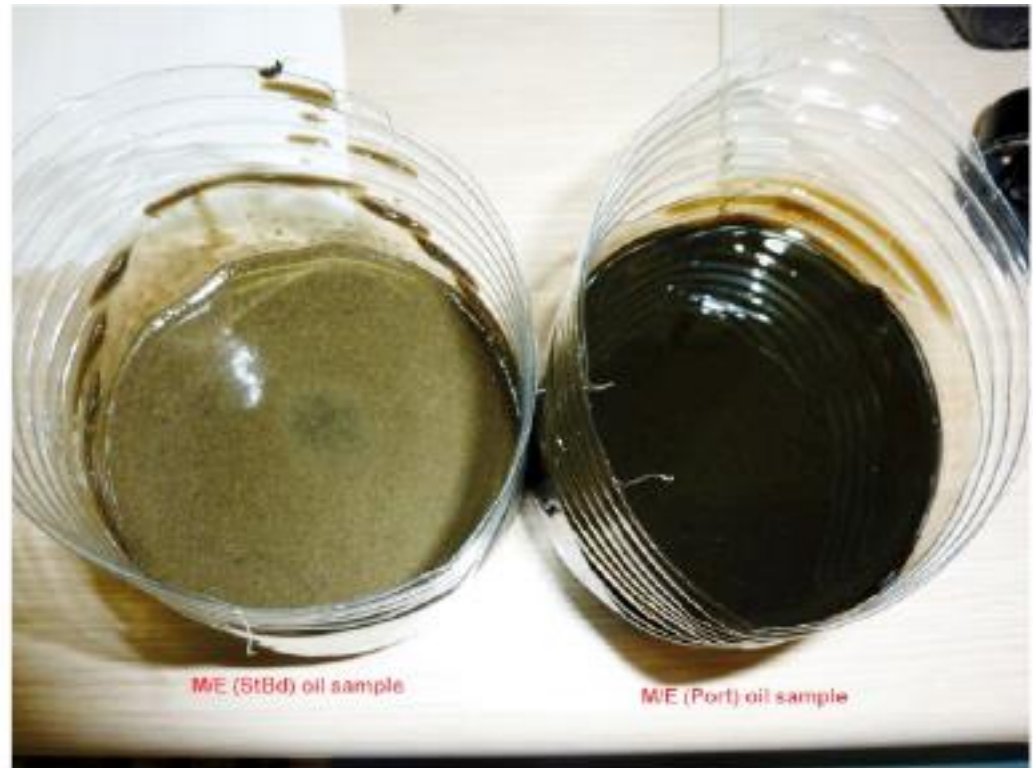
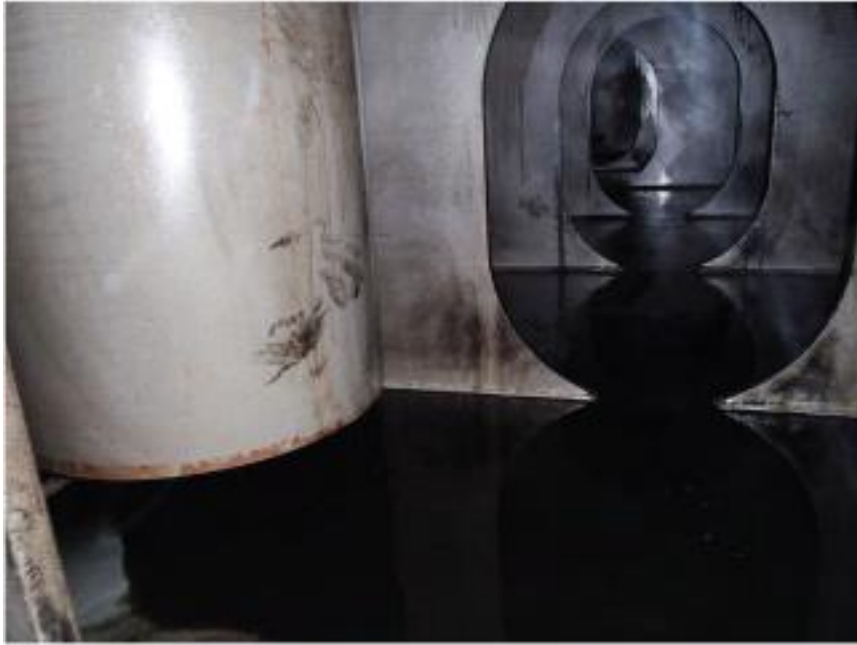
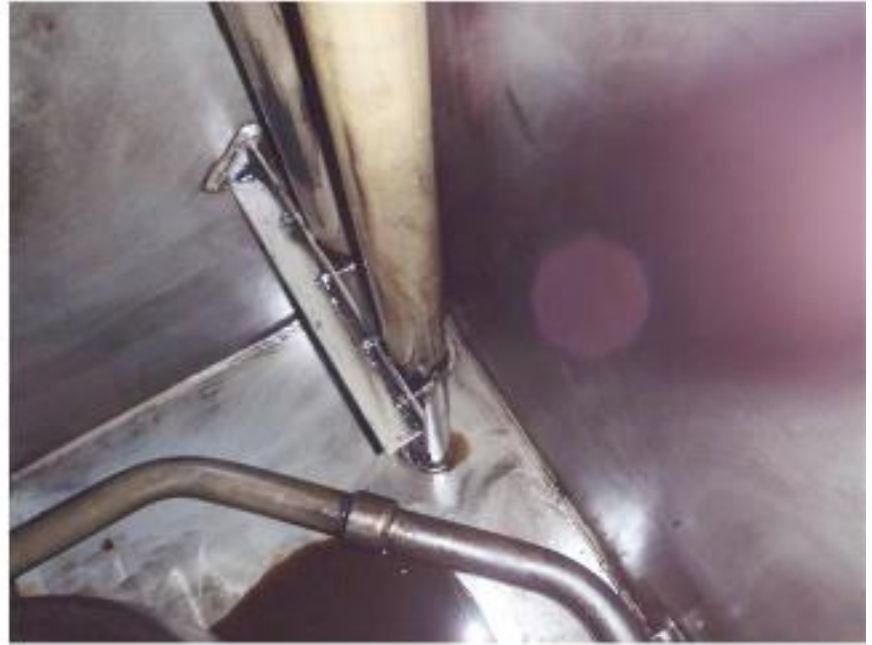
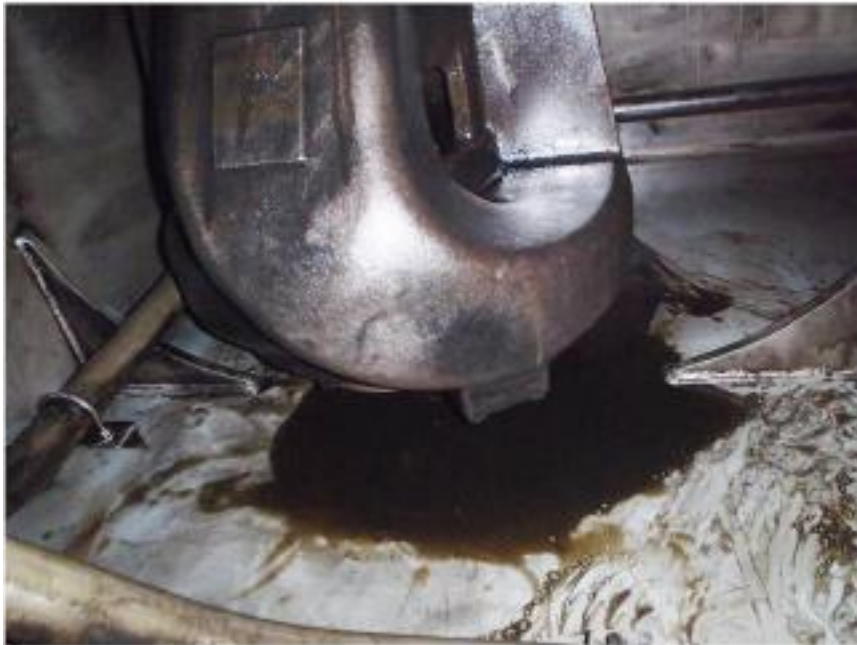
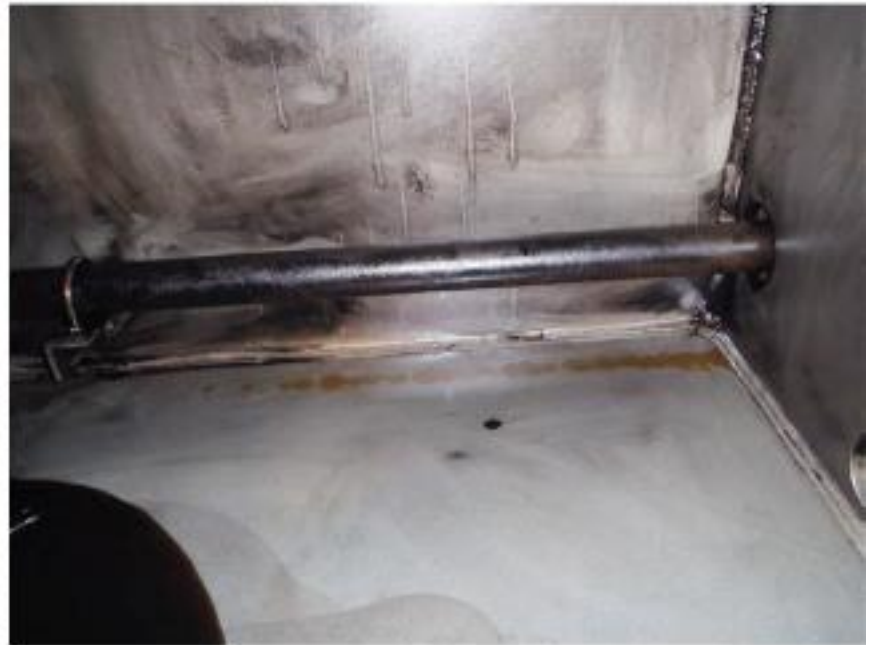
## Main engine sump oil contaminated by water

Indirect indication – ascertained on earlier stage: repetitive occurrence of “ME (S) Illegal ELFI-FIVA position (CCU1-6) Slowdown” alarm pop up on MOP screen:  
Frequent FIVA cleaning and overhauling did not bring positive effect

Direct indication – ascertained on later stage: water presence in oil abt. 0.48% what caused frequent FIVA malfunction and consequently engine slowdown. Corrective measures: immediate oil analysis for water presence on board and in laboratory has revealed excessive oil deterioration by water. After complete oil drain the source of contamination ascertained as damaged piece of steam heating coil where part of condensate penetrated inside sump tank via pin hole caused by heavy friction of coil against U-clamp. Coil repaired, sump tank was cleaned. Eventually complete system oil was replaced with fresh one.
