FINAL REPAIR AND CONDITION SURVEY REPORT

Vessel/ Installation	: XXXXXXXXXXXXXX	Location	: Mykolaiv, Ukraine
Customer	: XXXXXXXXXXXXXX Management Pte Ltd	Date	: 18-20/12/2021
Job number	: 1	Client Ref No	: 1/TSM form No 062

Description of Job:

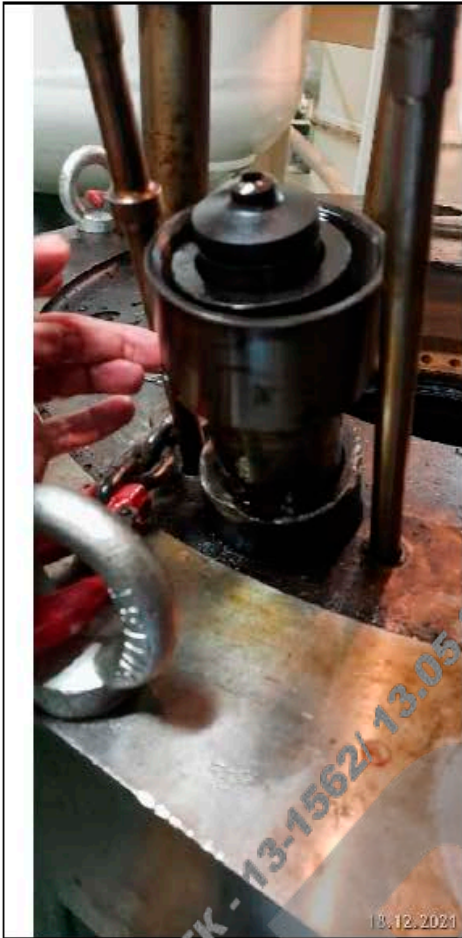
Damage inspection

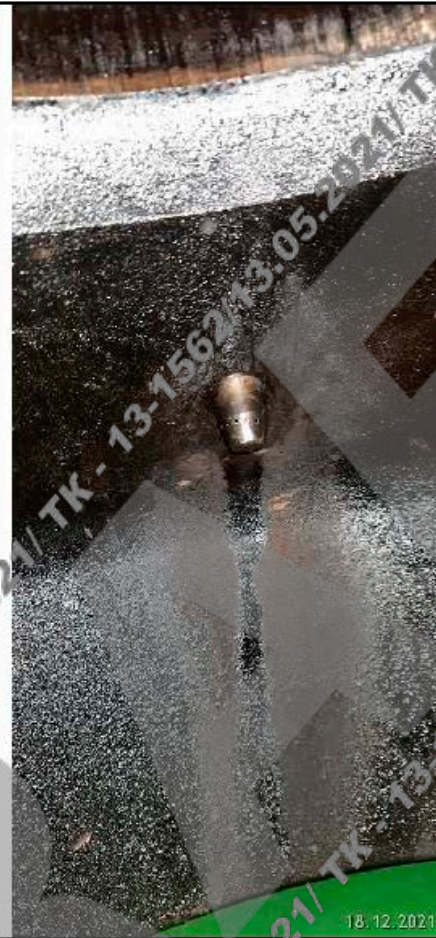
Damage inspection

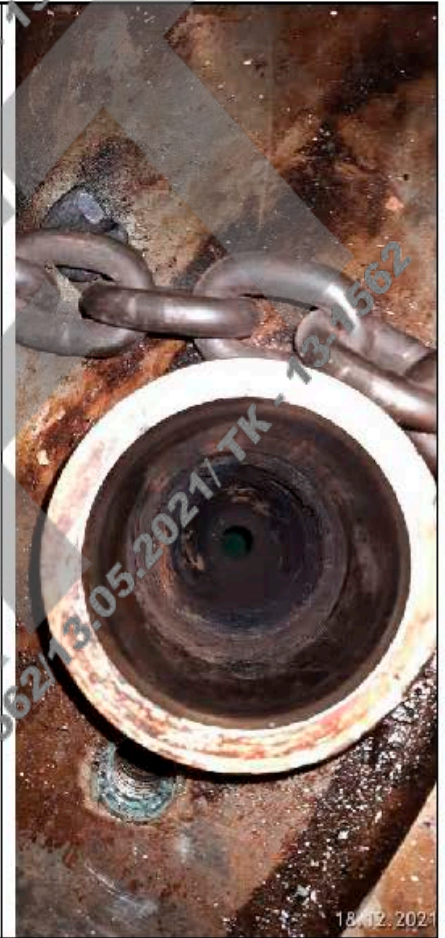
Damage inspection

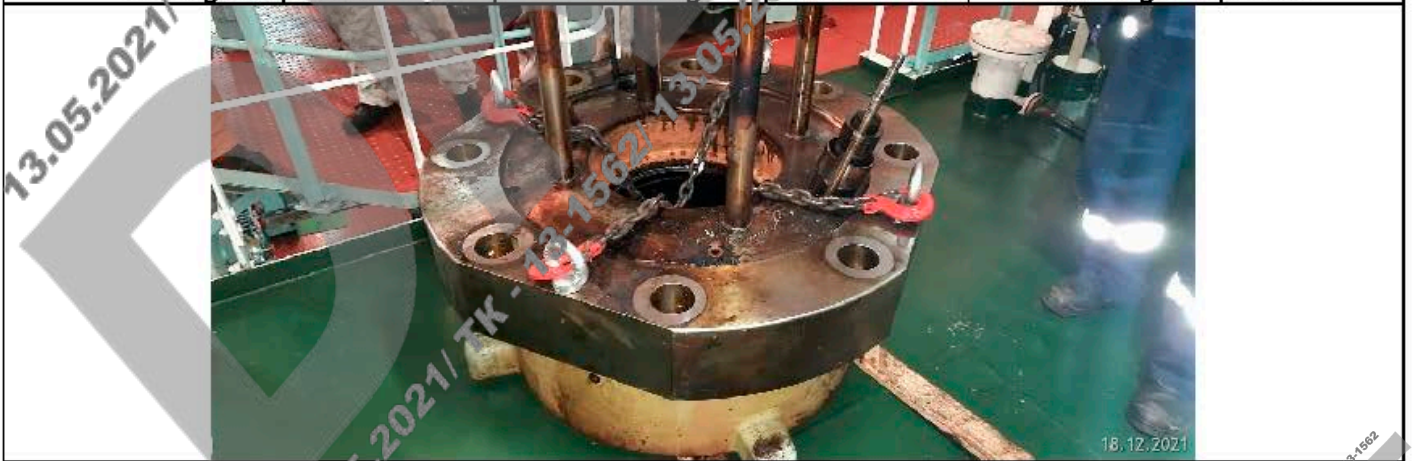
Damage inspection

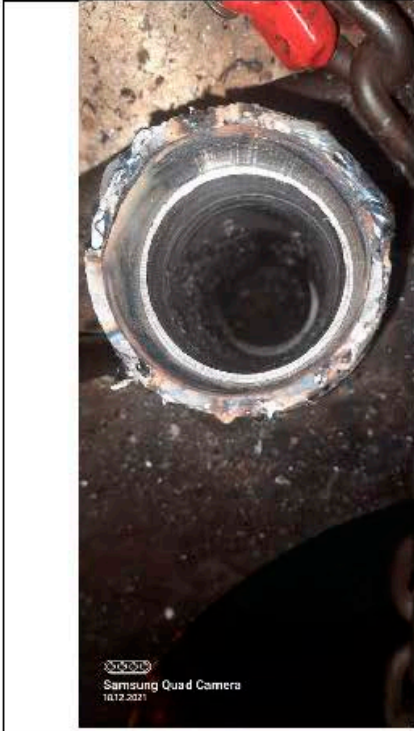
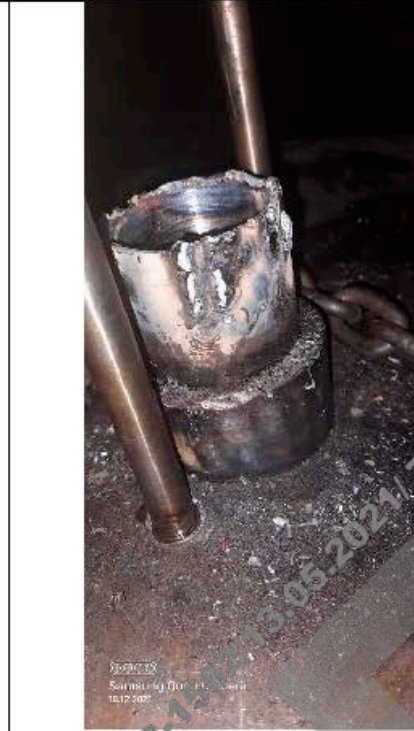
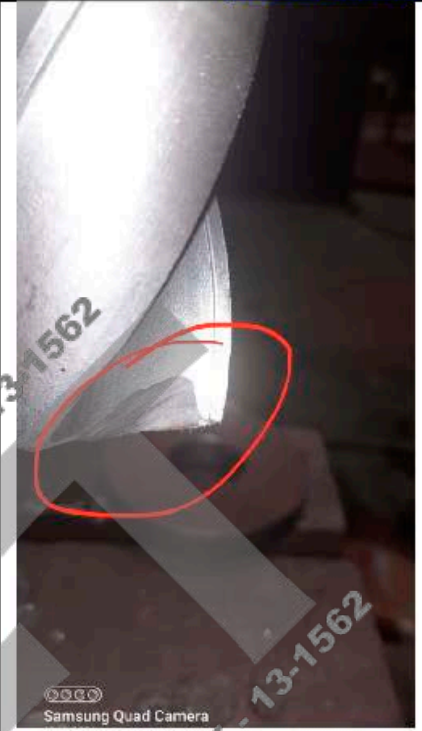
Welded additional pipe to make a wrench lever

Drill's bore worn out

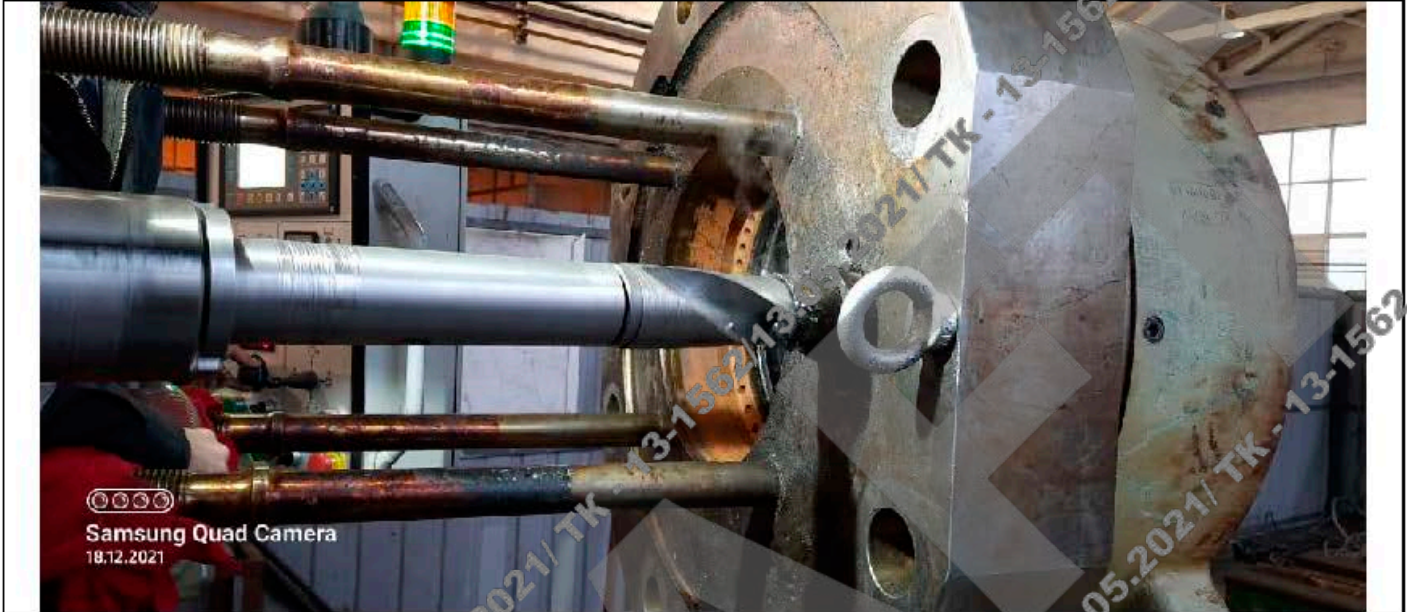
Second bore drill excessively worn out

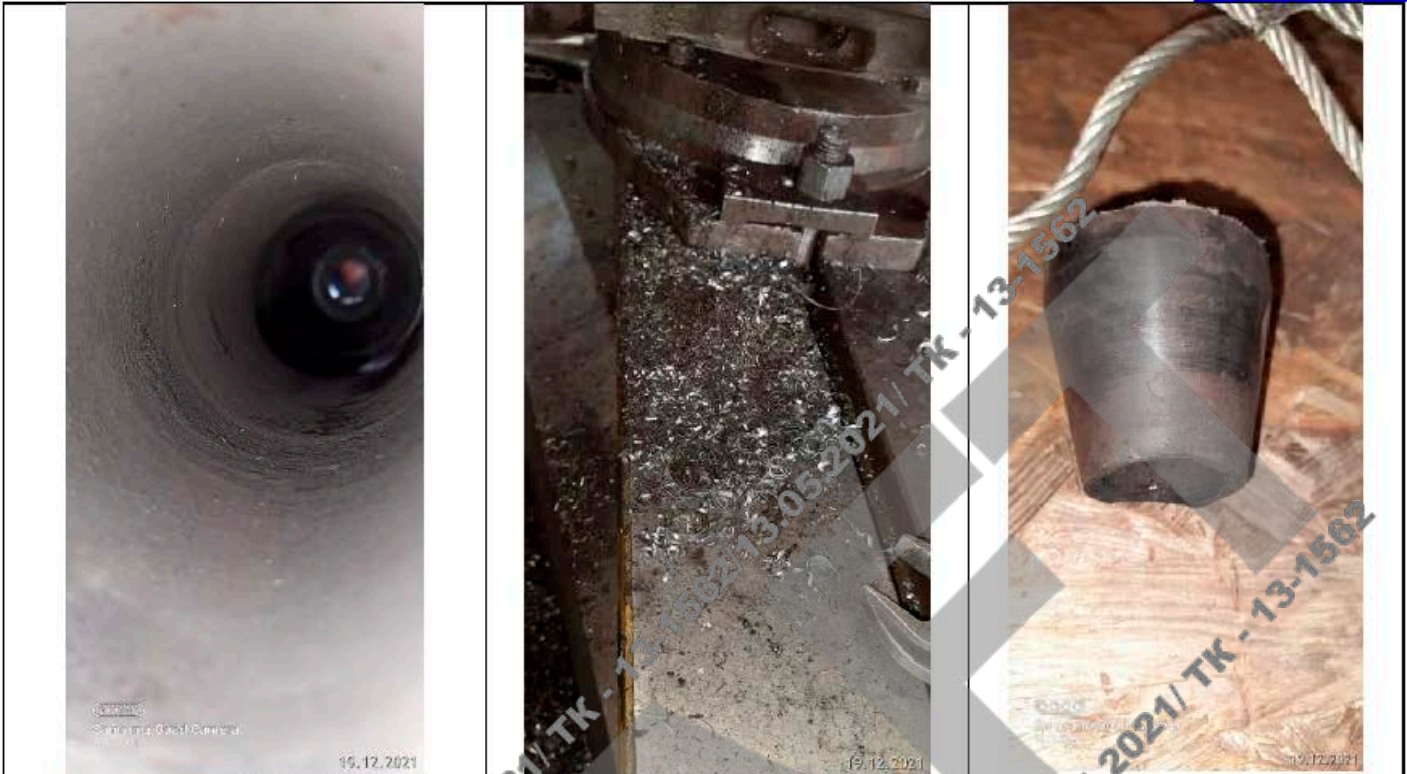
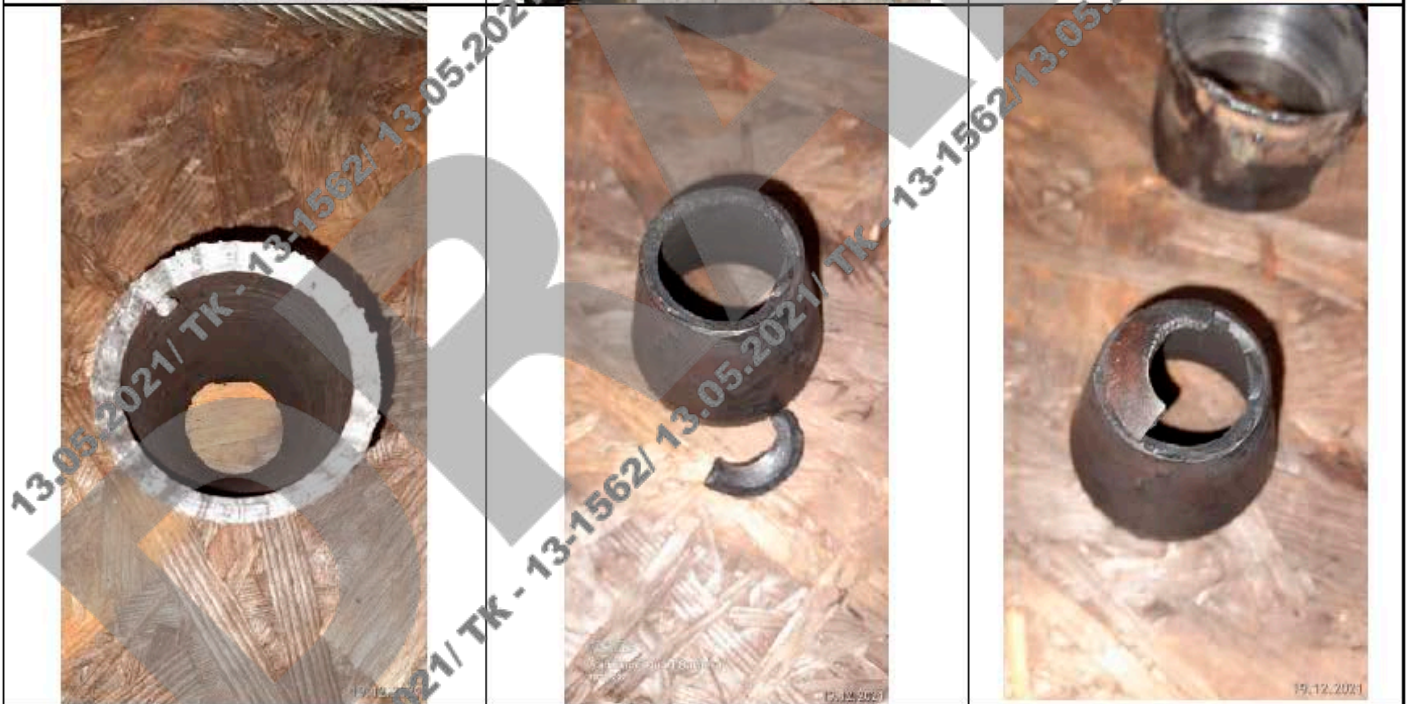
It found that the lower part of fuel valve holder was damaged earlier as the fault point surface was completely covered by carbon deposits.

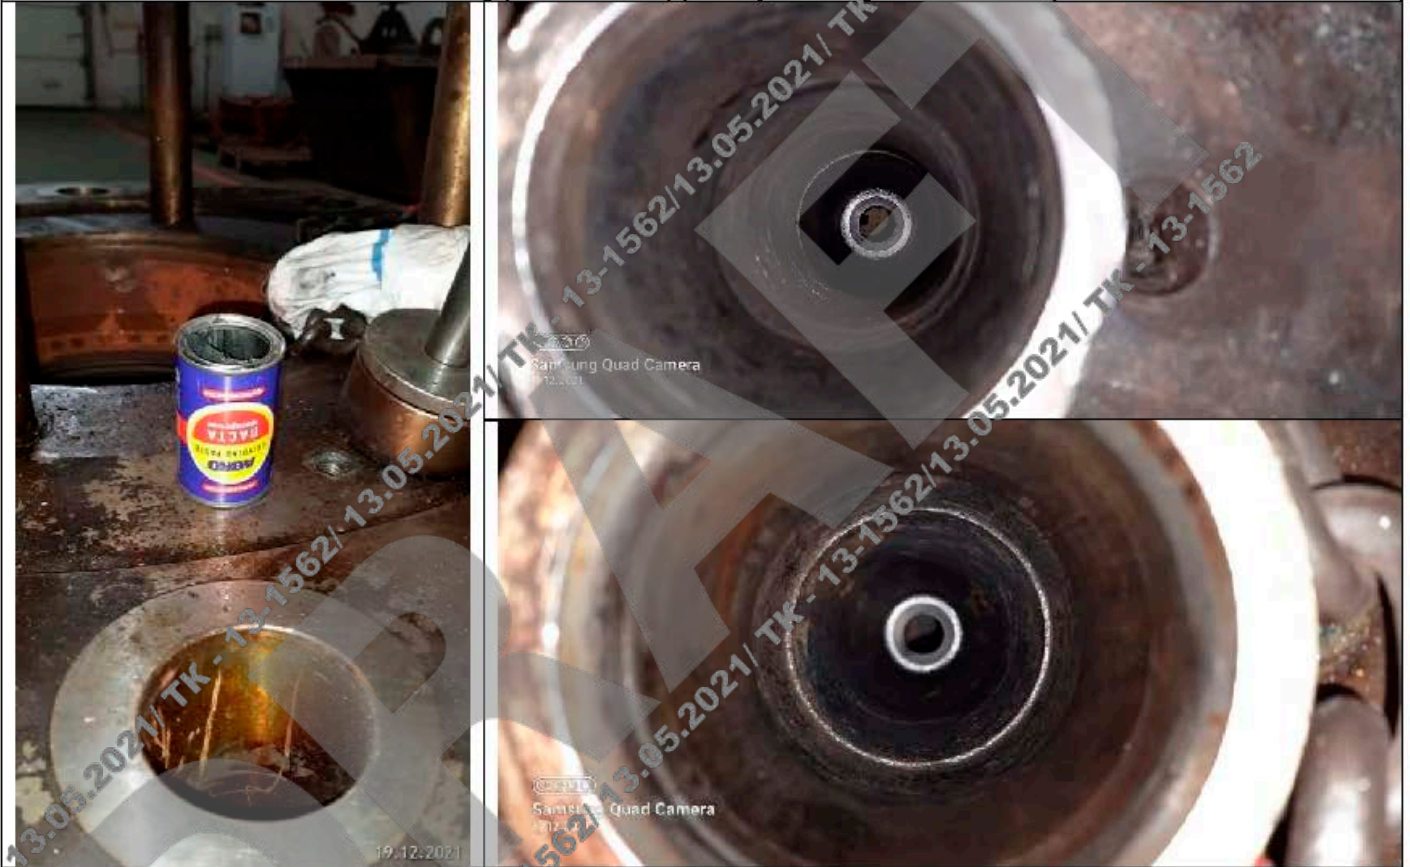
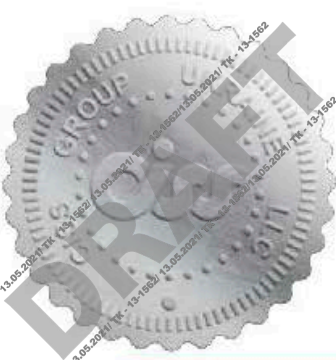
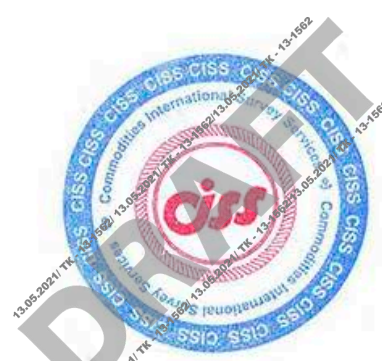
The grinding mandrel (plate 90151-0206, 058)
was found worn out and it is highly recommended to replace it.
