FINAL REPAIR AND CONDITION SURVEY REPORT

Vessel/ Installation	: XXXXXXXXXXXXXX	Location	: Mykolaiv, Ukraine
Customer	: XXXXXXXXXXXXXX Management Pte Ltd	Date	: 18-20/12/2021
Job number	: 1	Client Ref No	: 1/TSM form No 062

Description of Job:

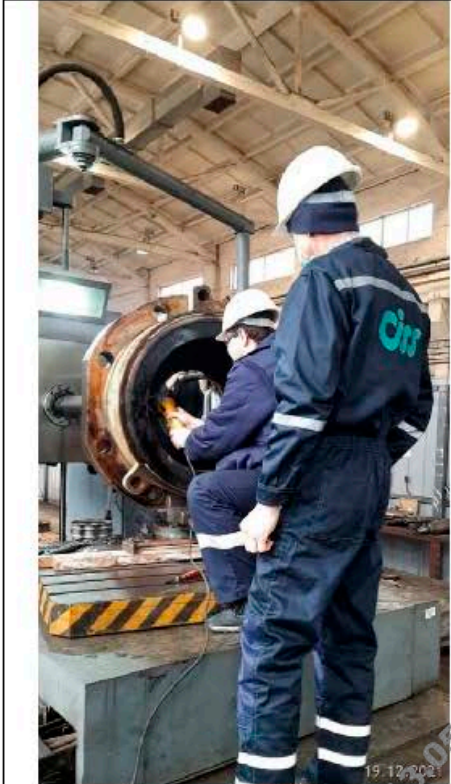
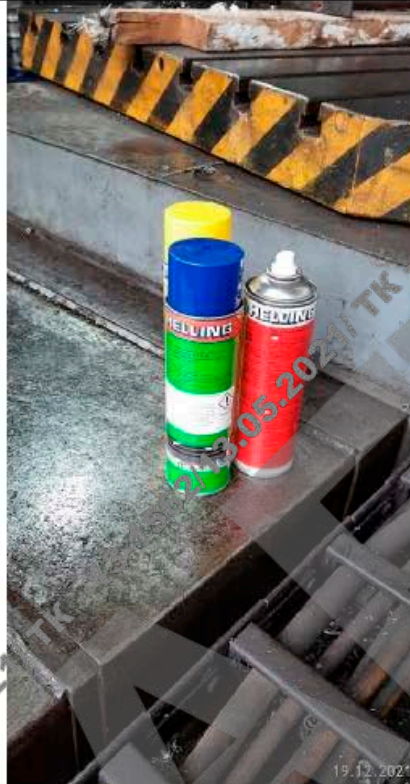
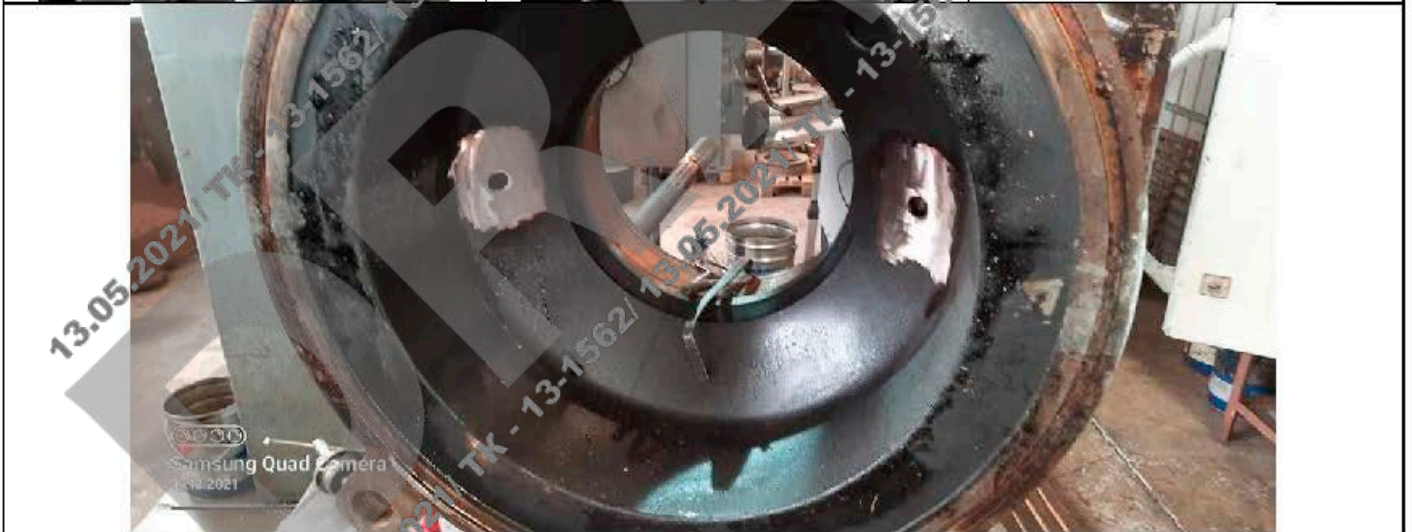
Samsung Quad Camera
19.12.2021

Crack test 19.12.2021

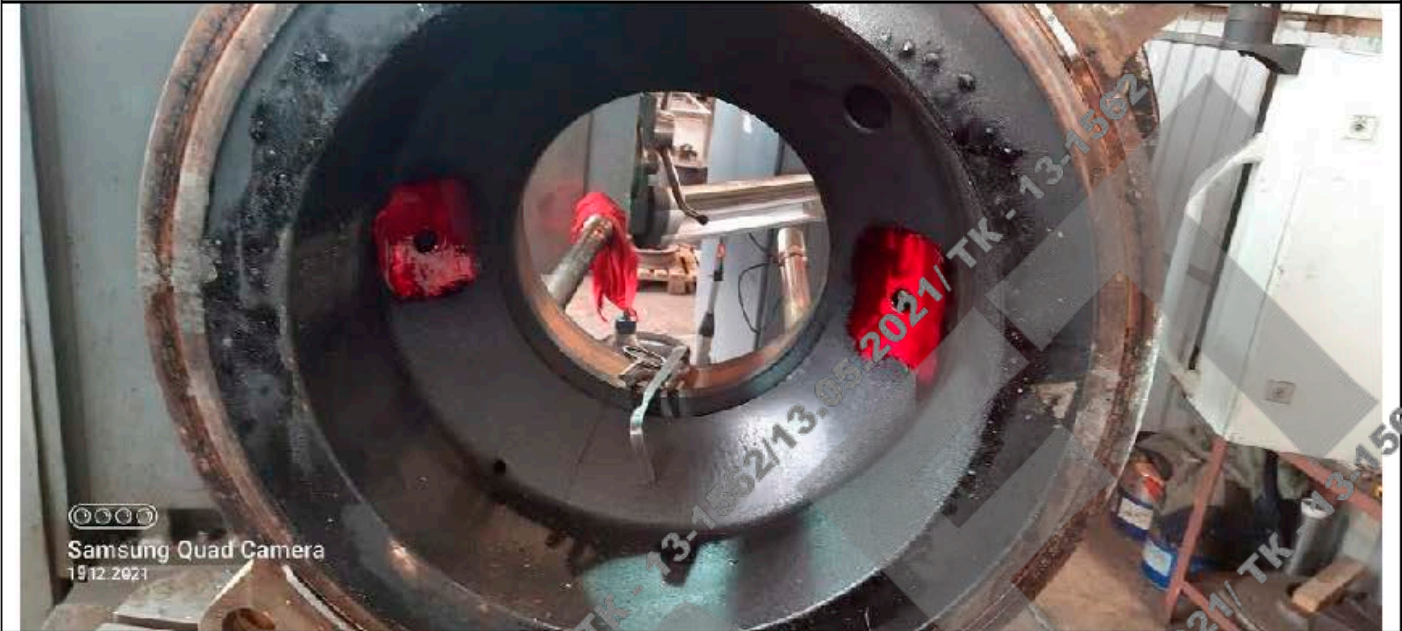
Samsung Quad Camera
19.12.2021

Crack test 19.12.2021

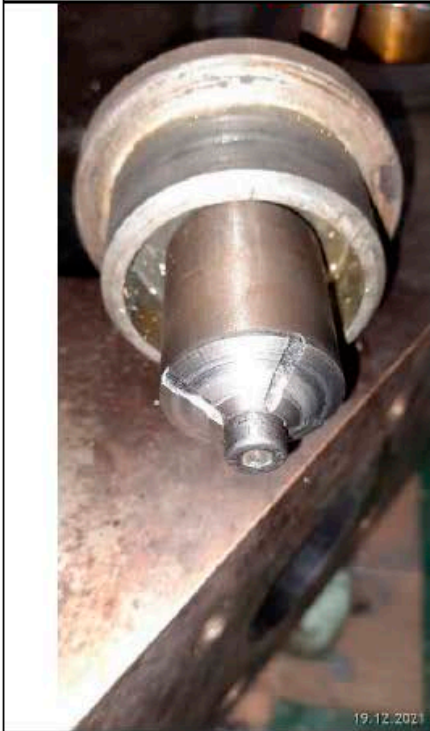
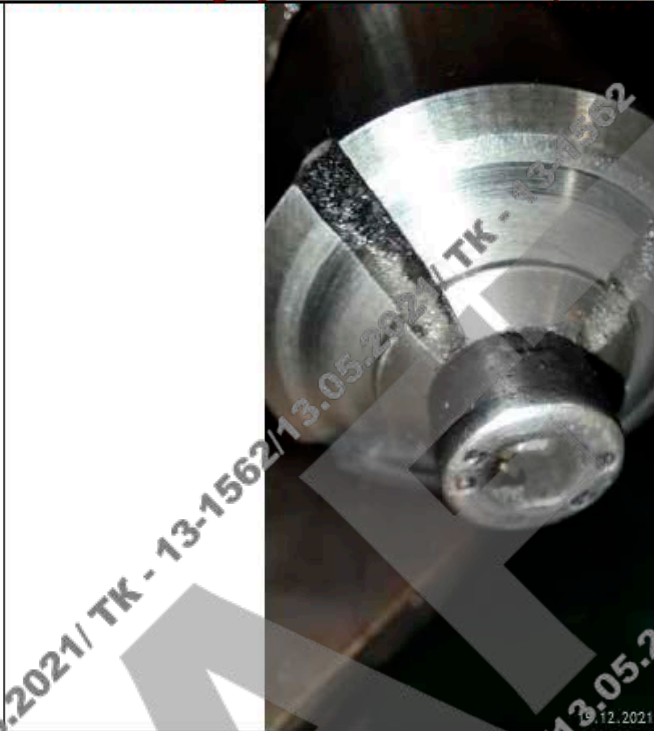
19.12.2021

The grinding mandrel (plate 90151-0206, 058)
was found worn out and it is highly recommended to replace it.
